Manhole Inspection Summary

Manhole # S51CC_005MH

Insp Date: **6/27/08 11:19 AM**

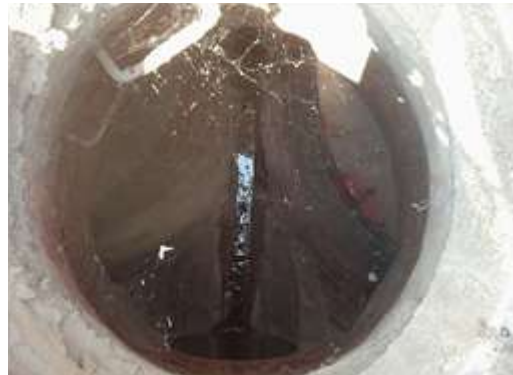
Top View

Condition: ☐ Sound ☐ Cracked ☐ Root Intrusion ☒ **Loose Brick** ☐ Deteriorated

Infiltration: ☐ None ☐ Joint ☐ Cracks ☒ **Mortar** ☐ Roots ☐ Wall

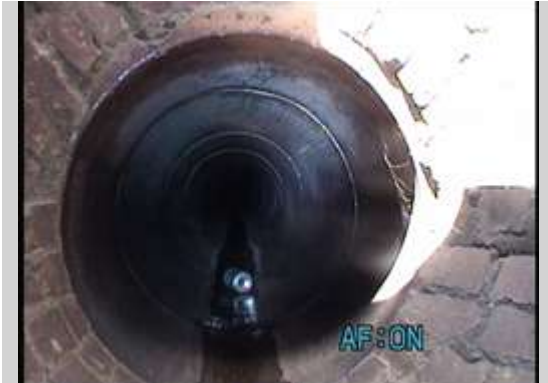
12 O'Clock Outflow

21 in. Circular Gravity Sewer
Pipe Out @ 12 O'Clock

Pipe Height: **21.6** (in.) Rod and Bar (Angled)
Pipe Material: **Clay** ☐ Pipe Lined
Invert Depth: **7.60** (ft.) Flow Characteristics: **Slow**
Deposits: ☒ None ☐ Mud ☐ Sludge ☐ Debris ☐ Grease
Silt Depth: (in.) Deposits Extent:
Infiltration: **None** Pipe Seal Cond: **Sound**

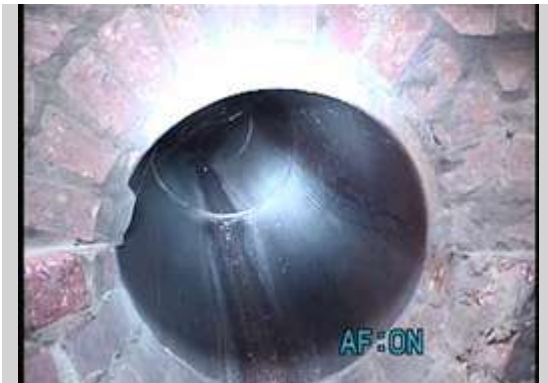
5 O'Clock Inflow

15 in. Circular Gravity Sewer
Pipe In @ 5 O'Clock

Pipe Height: **15.6** (in.) Rod and Bar (Angled)
Pipe Material: **Clay** ☐ Pipe Lined
Invert Depth: **7.15** (ft.) Flow Characteristics: **Slow**
Deposits: ☒ None ☐ Mud ☐ Sludge ☐ Debris ☐ Grease
Silt Depth: (in.) Deposits Extent:
Infiltration: **None** Pipe Seal Cond: **Sound**

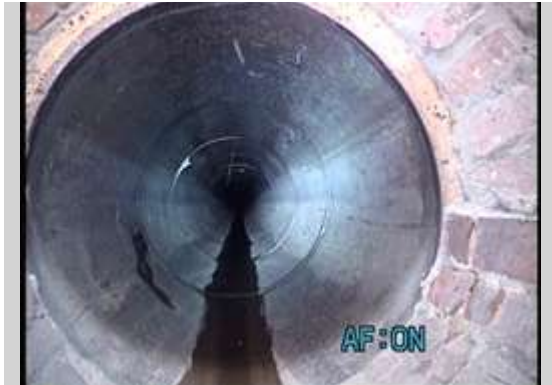
6 O'Clock Inflow

21 in. Circular Gravity Sewer

Pipe In @ 6 O'Clock

Pipe Height: **21.6** (in.) Rod and Bar (Angled)

Pipe Material: **Clay** ☐ Pipe Lined

Invert Depth: **7.55** (ft.) Flow Characteristics: **Slow**

Deposits: ☒ None ☐ Mud ☐ Sludge ☐ **Debris** ☐ Grease

Infiltration: **None**

Pipe Seal Cond: **Sound**

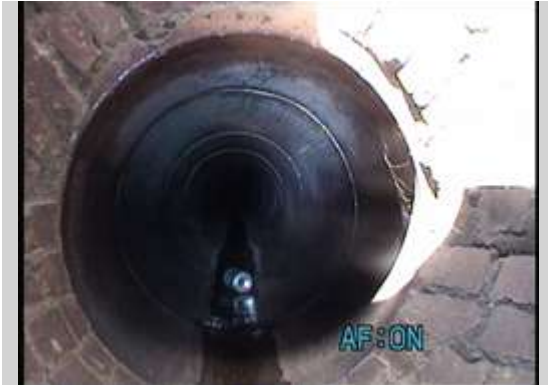
12 O'Clock Outflow

21 in. Circular Gravity Sewer
Pipe Out @ 12 O'Clock

Pipe Height: **21.6** (in.) Rod and Bar (Angled)
Pipe Material: **Clay** ☐ Pipe Lined
Invert Depth: **7.60** (ft.) Flow Characteristics: **Slow**
Deposits: ☒ None ☐ Mud ☐ Sludge ☐ Debris ☐ Grease
Silt Depth: (in.) Deposits Extent:
Infiltration: **None** Pipe Seal Cond: **Sound**

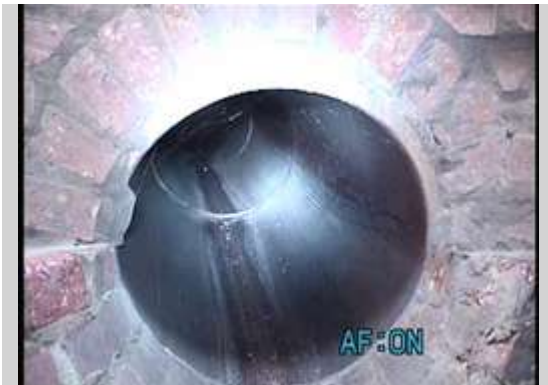
5 O'Clock Inflow

15 in. Circular Gravity Sewer
Pipe In @ 5 O'Clock

Pipe Height: **15.6** (in.) Rod and Bar (Angled)
Pipe Material: **Clay** ☐ Pipe Lined
Invert Depth: **7.15** (ft.) Flow Characteristics: **Slow**
Deposits: ☒ None ☐ Mud ☐ Sludge ☐ Debris ☐ Grease
Silt Depth: (in.) Deposits Extent:
Infiltration: **None** Pipe Seal Cond: **Sound**

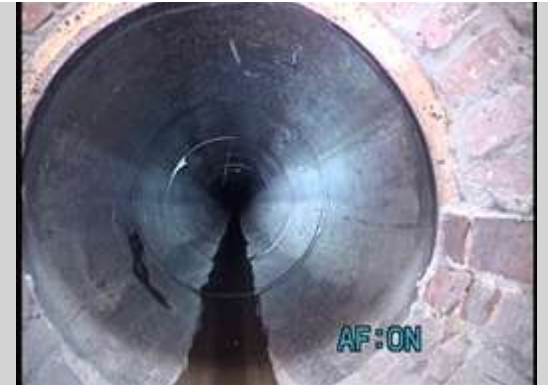
6 O'Clock Inflow

Pipe In @ 6 O'Clock

Pipe Height: **21.6** (in.) Rod and Bar (Angled)

Pipe Material: **Clay** ☐ Pipe Lined
